FINAL SITE INSPECTION REPORT
FORT BLISS
EL PASO, TEXAS

Site: Former Maneuver Area – Area 9

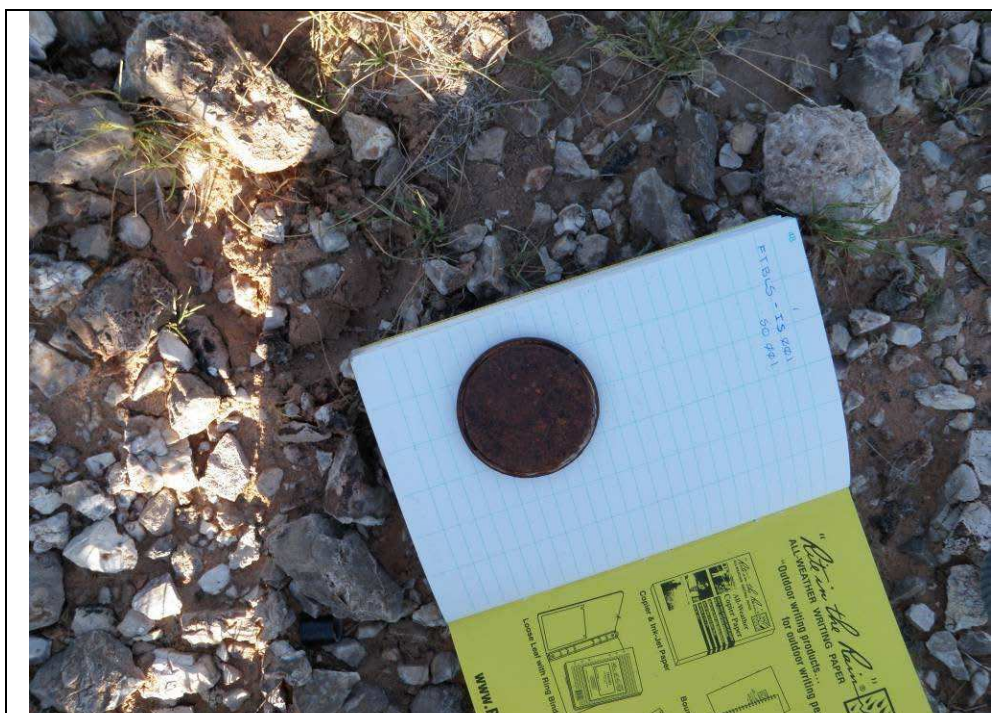
Photograph No. 15

Description: M104 illuminating flare canister lid

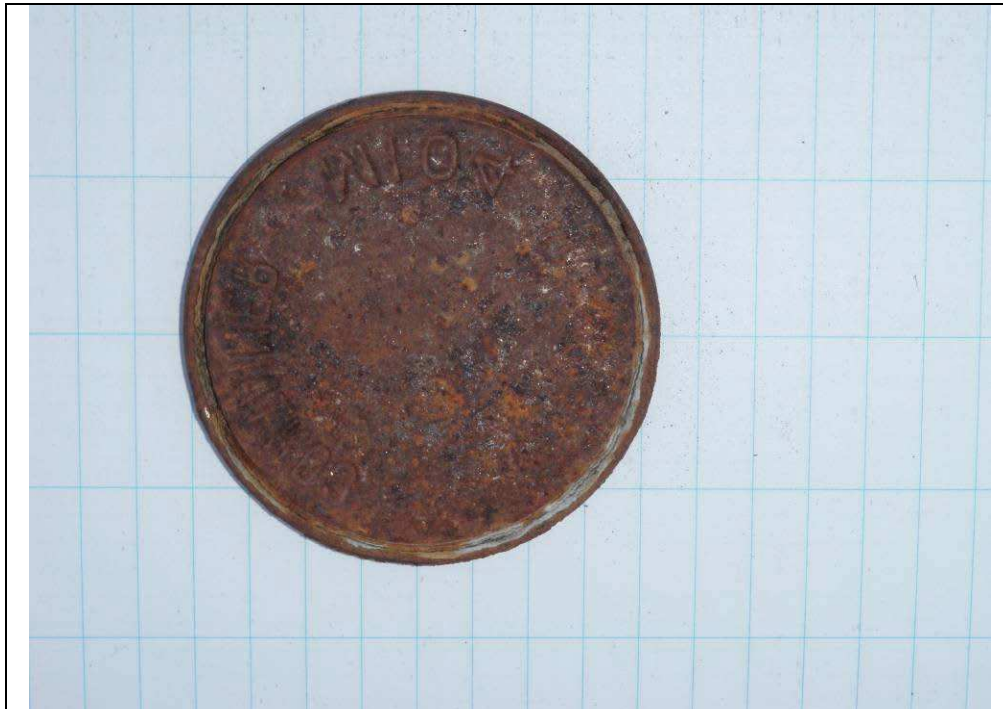
Photograph No. 16

Description: M104 illuminating flare canister lid

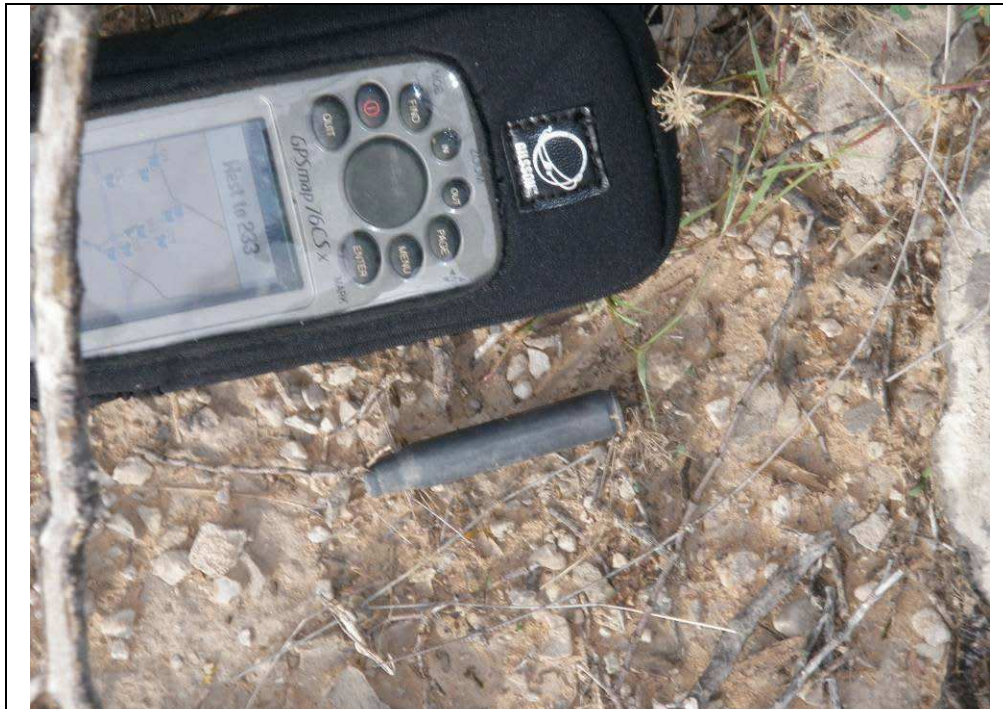
Photograph No. 26	Date: 10/5/2010	Time: 08:44
-------------------	-----------------	-------------

Description: FA 48 .30-06 blank shell casing
--

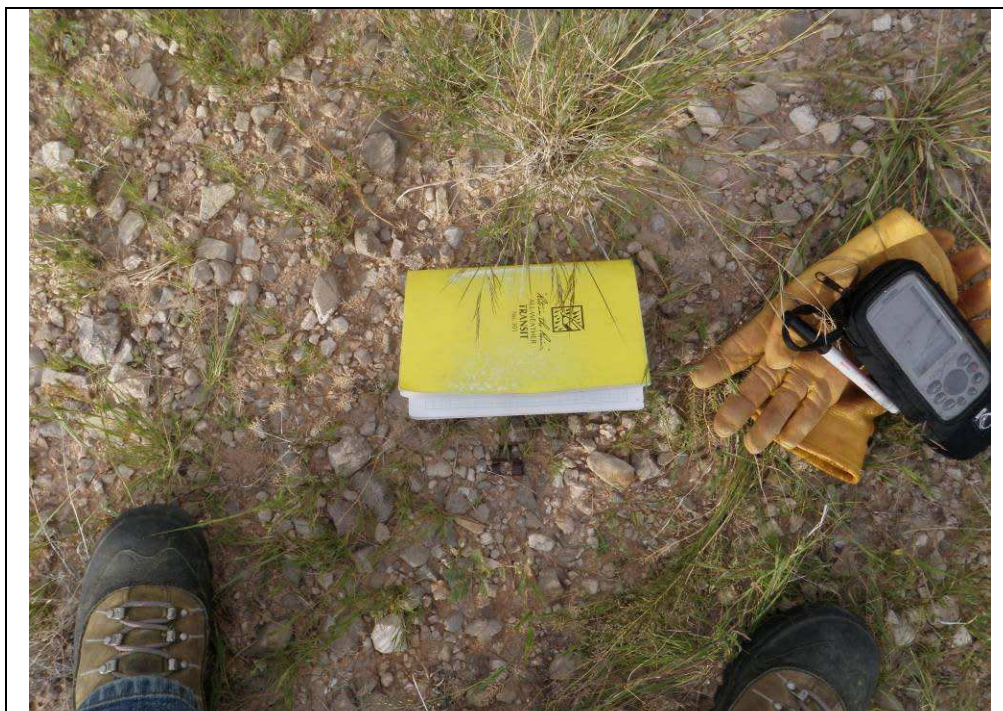
Photograph No. 29

Description: M1 Garand clip and .30-06 shell casings

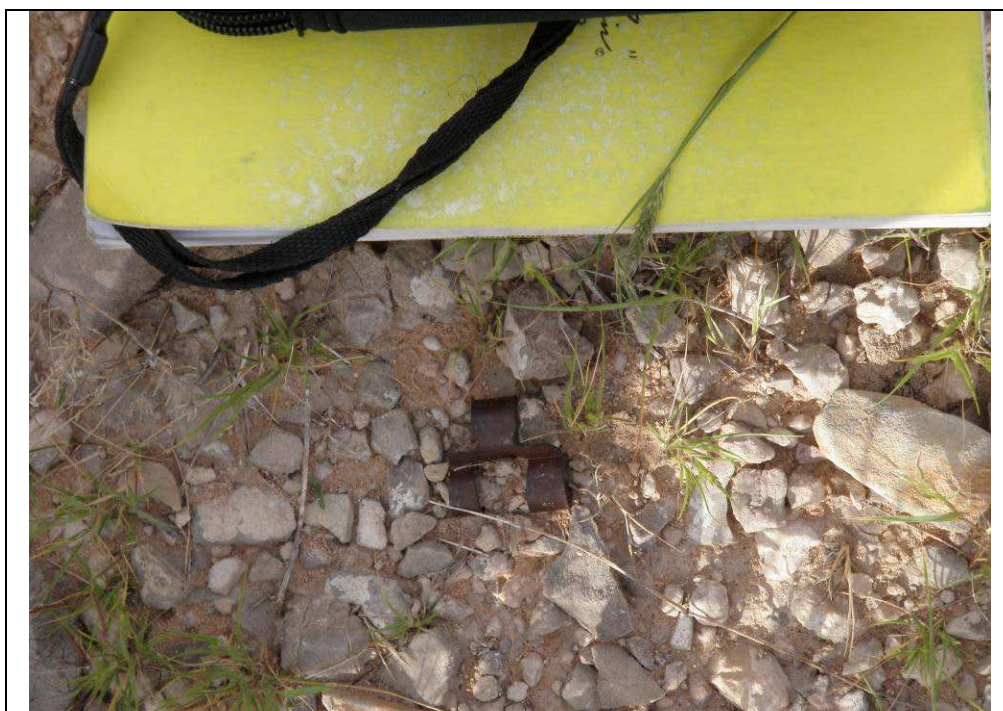
Photograph No. 30

Description: .30-caliber Browning machine gun link

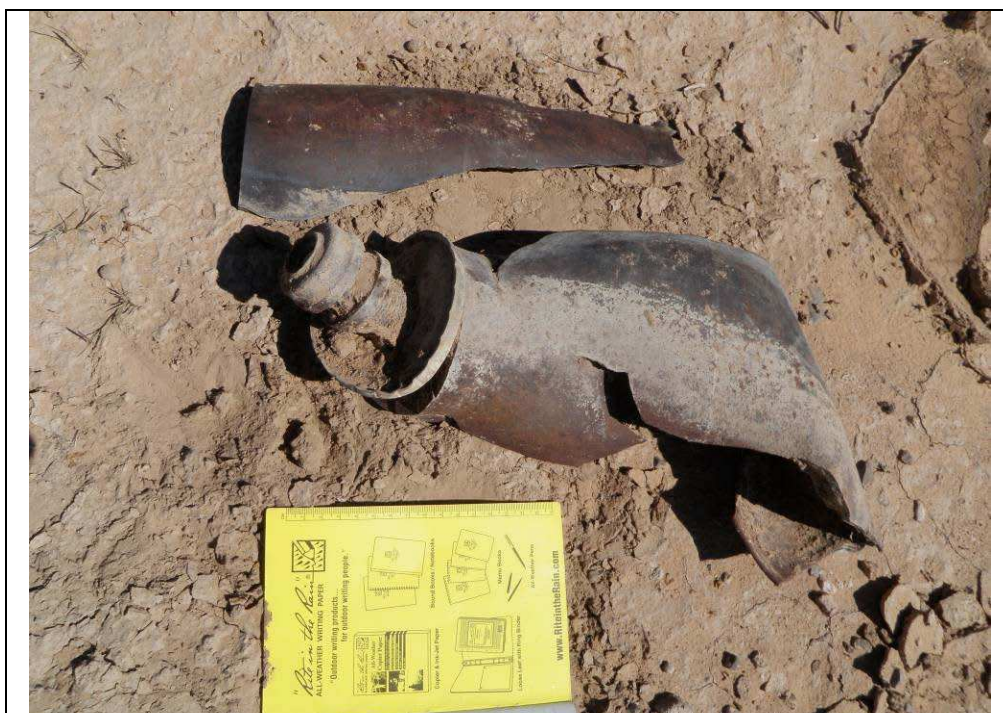
Photograph No. 96	Date: 10/7/2010	Time: 12:27
Site: Former Maneuver Area – Area 4		
Description: Obturator/rotating band from 4.2-inch mortar shell

Additional information regarding 4.2 mortars observed in Area 4:

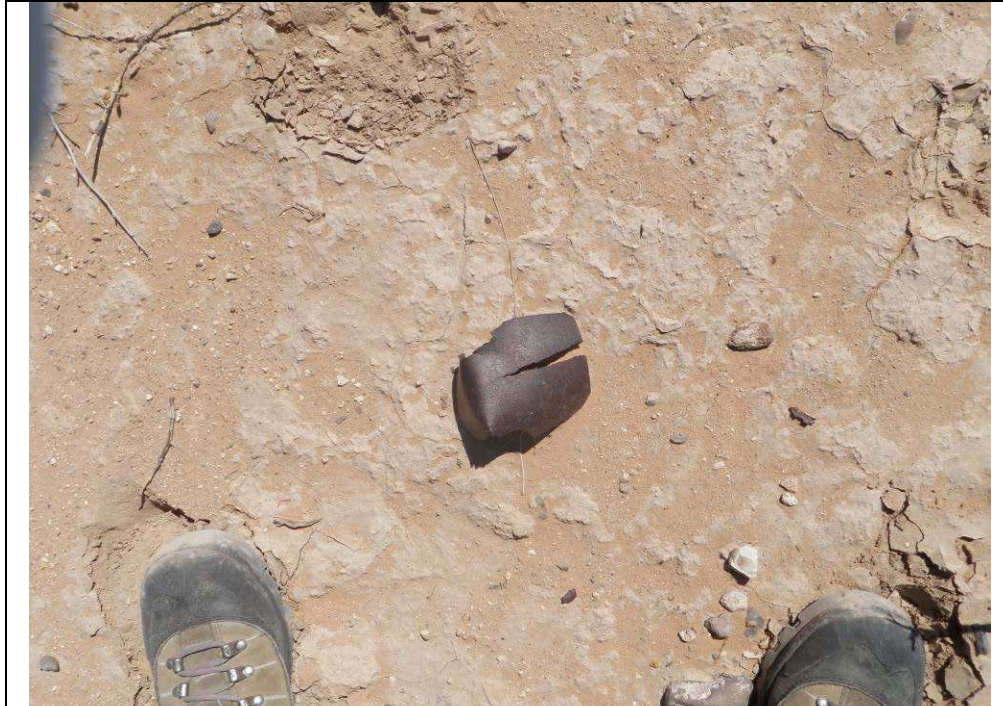
Photograph No. 104	Date: 10/7/2010	Time: 12:51
Site: Former Maneuver Area – Area 4		
Description: Facing east – area of 4.2-inch mortar fragments

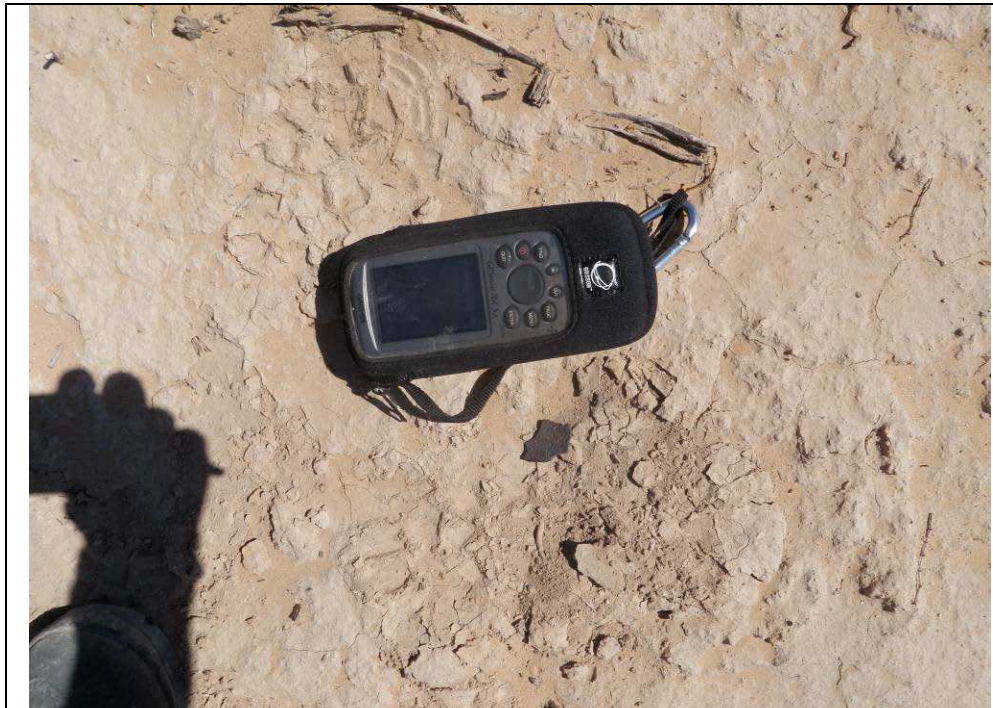
Photograph No. 111	Date: 10/7/2010	Time: 13:03
--------------------	-----------------	-------------

Description: Fuze from 4.2-inch mortar shell
--

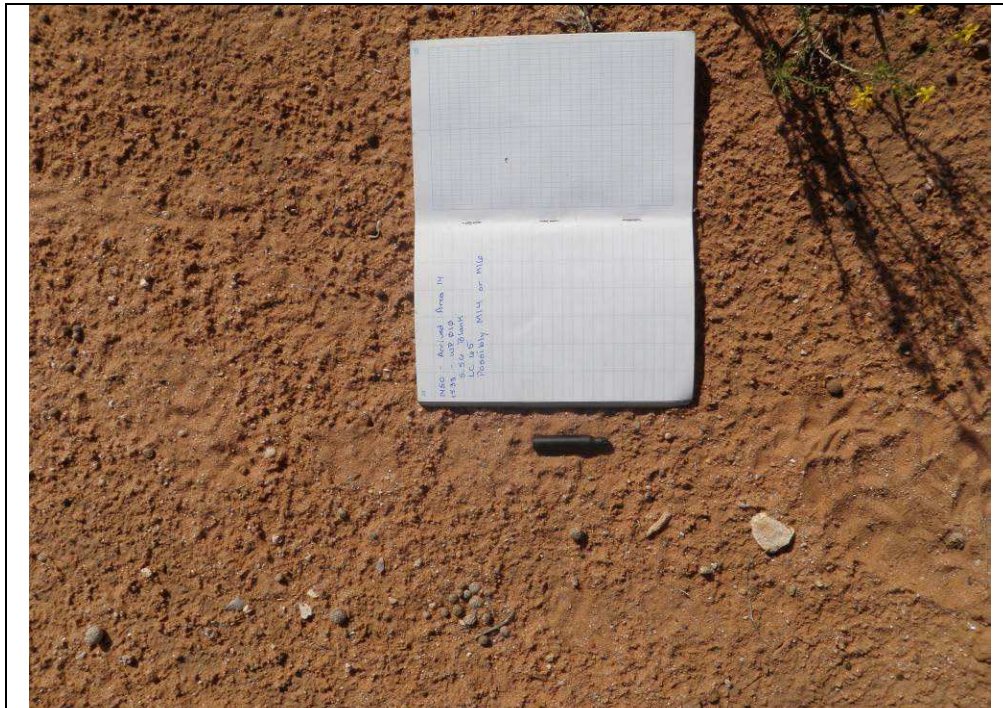
Photograph No. 131	Date: 10/8/2010	Time: 15:28
Site: Former Maneuver Area – Area 14		
Description: Military tent stake; consistent with bivouac site
